□ 11 34 004 Adjusting valve clearance

R1200GS 6K Service done, with pics.

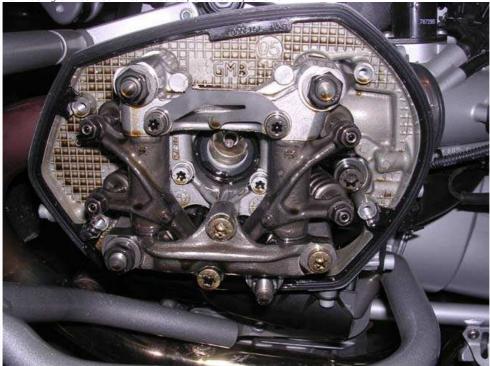
The cover came off the same as the 11GS, and easily cleared the H&B crash bars. However, the front engine cover would not even come close to coming off with the crash bars, so I pulled the plugs and rotated the engine using the rear wheel with the trans in 6th gear.

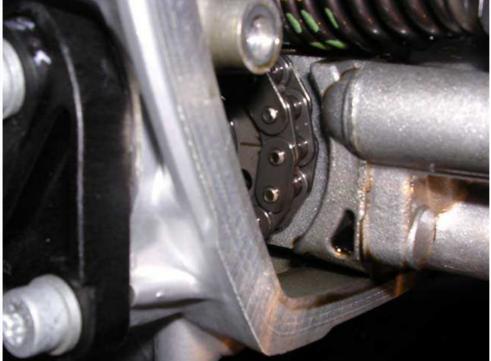
The right side of the 12GS has a cam arrow like on the R11 series, and it worked the same way. Have the arrow point straight out, and check the valves to make sure both intake and exhaust are loose. If not, rotate the engine so the arrow comes around again.

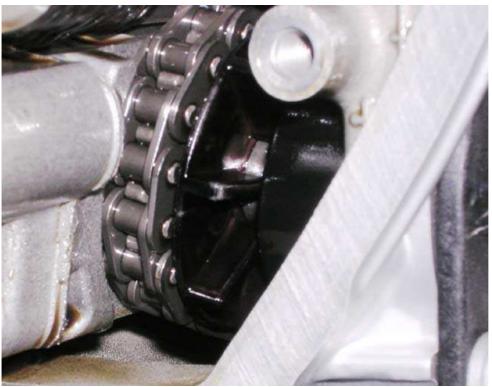
The left side had this attachment to the cam, I think it was some sort of position sensor since wires were attached to the cam cover. Hard to see, but there is a hole in it that lines up straight out when the cylinder is at TDC.

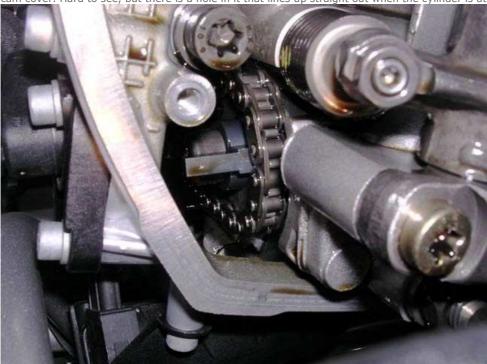
If you look back over on the right side, this is what you see when the left is at TDC, if the valves aren't loose to the touch, rotate the engine so the cam rotates 360 degrees.

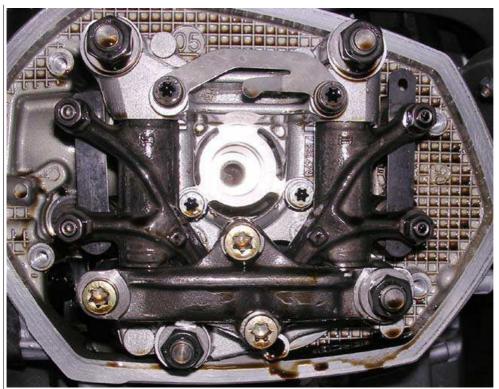
Insert the feeler gages, same as the 11/1150 series, .30mm on the exhaust, and .15 mm on the intake.

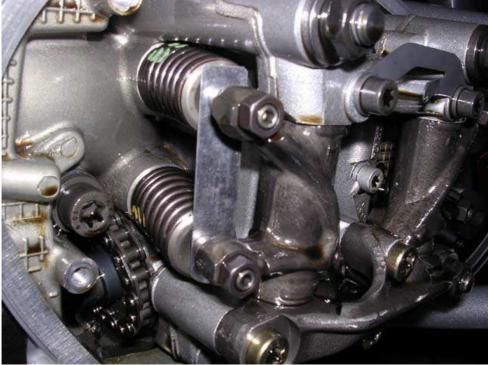
Intake side.

The exhaust side looks similar. Make sure you have both sides in, and all 4 valves covered when you get set to adjust the valves.

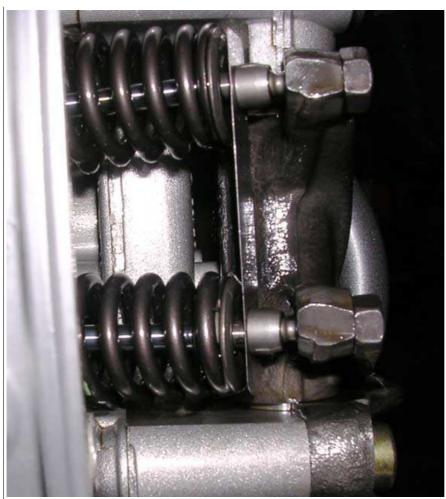
As you can see, the valves are parallell enough that no significant stress is placed on the feeler gages, and an acurate measurement is easily achieved.

First loosen the locking nuts, then insert the 3mm allen wrench and back off the adjustment approximately 1/4 turn. Ensure the allen wrench is near the top of a gravity stroke, then let it go. Gravity and resistance will stop it with the right amount of pressure on the valve.

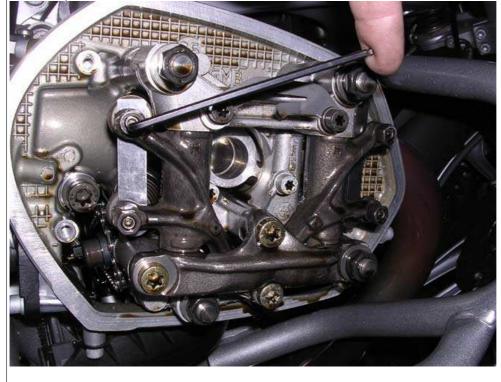
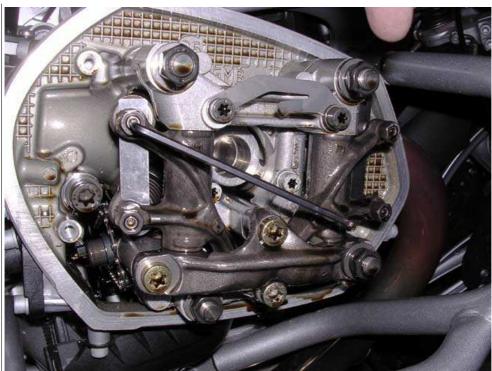
Tighten the lock nut without disturbing the position of the allen wrench. I hold it in place and tighten the locking nut. Pull from the center, and if the resistance is even, you have the adjusted correctly. There should be some slight resistance, but it should be easy to move the feeler gages. Rotate the engine and do the other side.
